# Cu-Alloying Effect on Structure Stability of Au Micro-Cantilever Evaluated by Long-Term Vibration Test

Evaluate long-term structure stability of the electrodeposited Au-Cu alloy

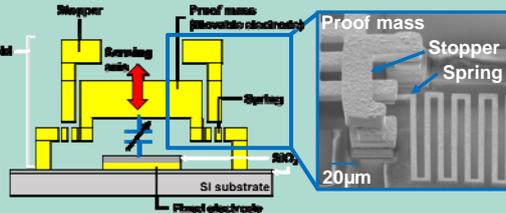
### Applications in MEMS Devices

- Au-based MEMS acceleration sensor<sup>[1]</sup> can detect Sub-1 $\mu$ G
- Concerns about reliability and lifetime due to gold's weak mechanical property

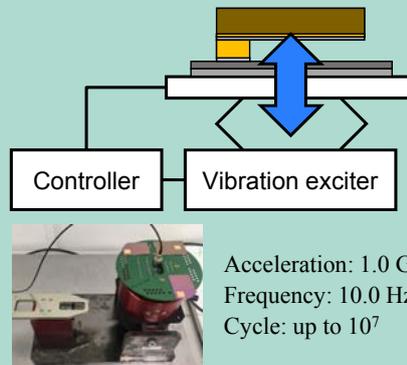
### Long-Term Vibration Test

- Measure height profile by 3D optical microscope
- The structure stability was quantified as  $\Delta h_{tip}$

$$\Delta h_{tip} = h_{tip} - h_{tip,0}$$

$h_{tip}$ : height of the surface at the tip  
 $h_{tip,0}$ : height of the tip before the vibration test

- Compared to micro-cantilever of pure Au plating

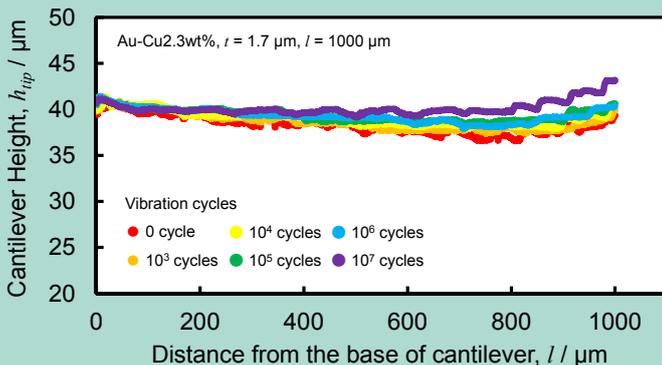
### OM Image and height profile after vibration fatigue test

- No cracks and defects
- Remains straight
- Hardly changed

- There were **no cracks and defects** in the cantilever beam after 10<sup>3</sup> ~ 10<sup>7</sup> cycles of vibration
- **Structural stability was enhanced** by alloying with Cu against vibration fatigue

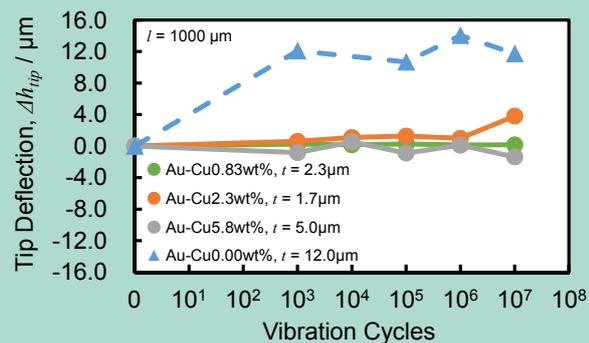
### Structure stability after vibration fatigue test

- Alloying with Cu

Small  $\Delta h_{tip}$

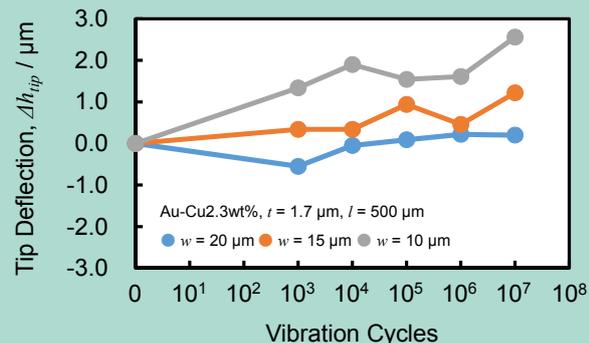
- Wide width

Small  $\Delta h_{tip}$
